Field Evaluation Of A Television Bore Hole Telescope

July 1966

State of California  
Business and Transportation Agency  
Department of Public Works  
Division of Highways

**NO. M & R 226468**

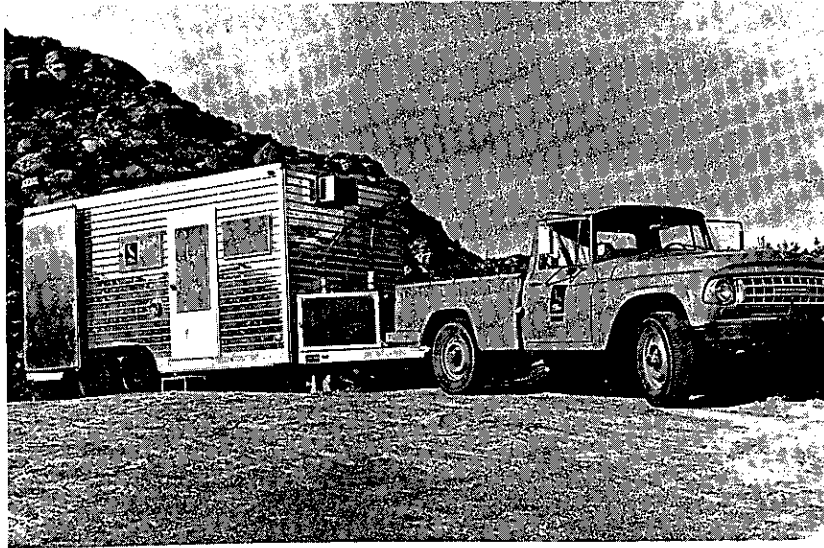
Photo 1 - Trailer-mounted Eastman International Television Bore Hole Telescope FB400.

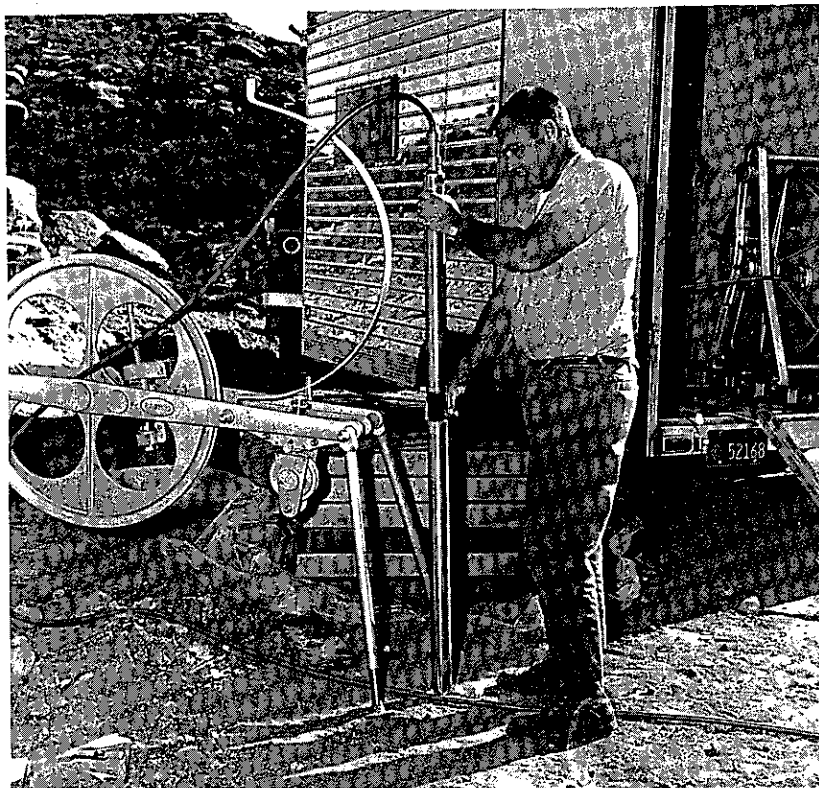
Photo 2 - Placement of cable on depth measuring wheel prior to lowering camera probe in hole.

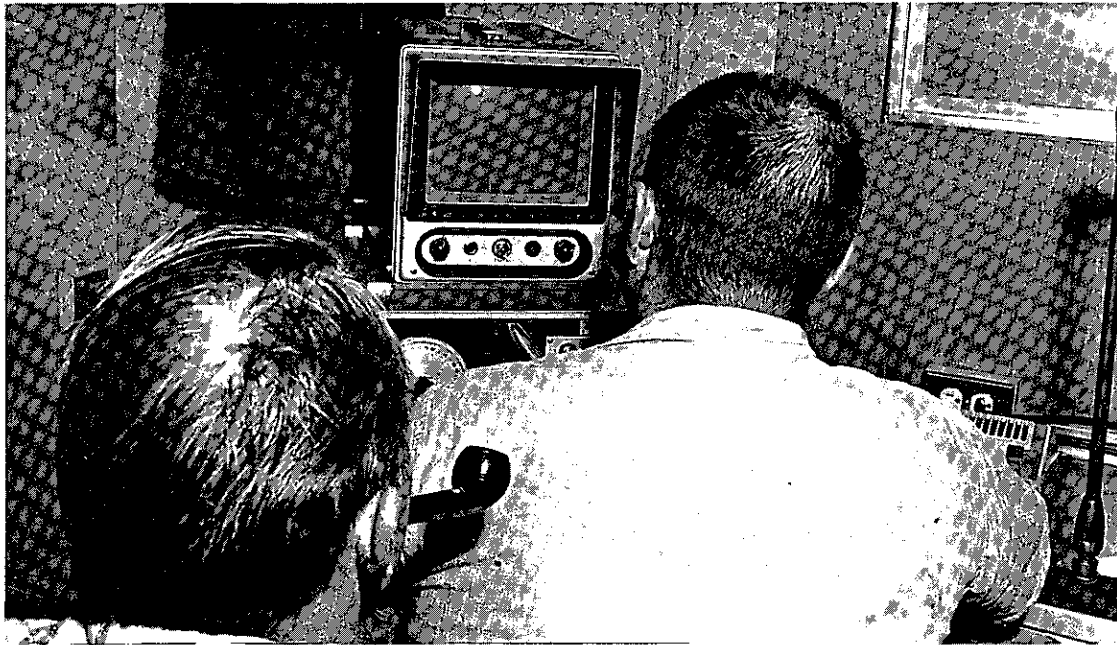
Photo 3 - Monitoring screen and control panel, in operation.

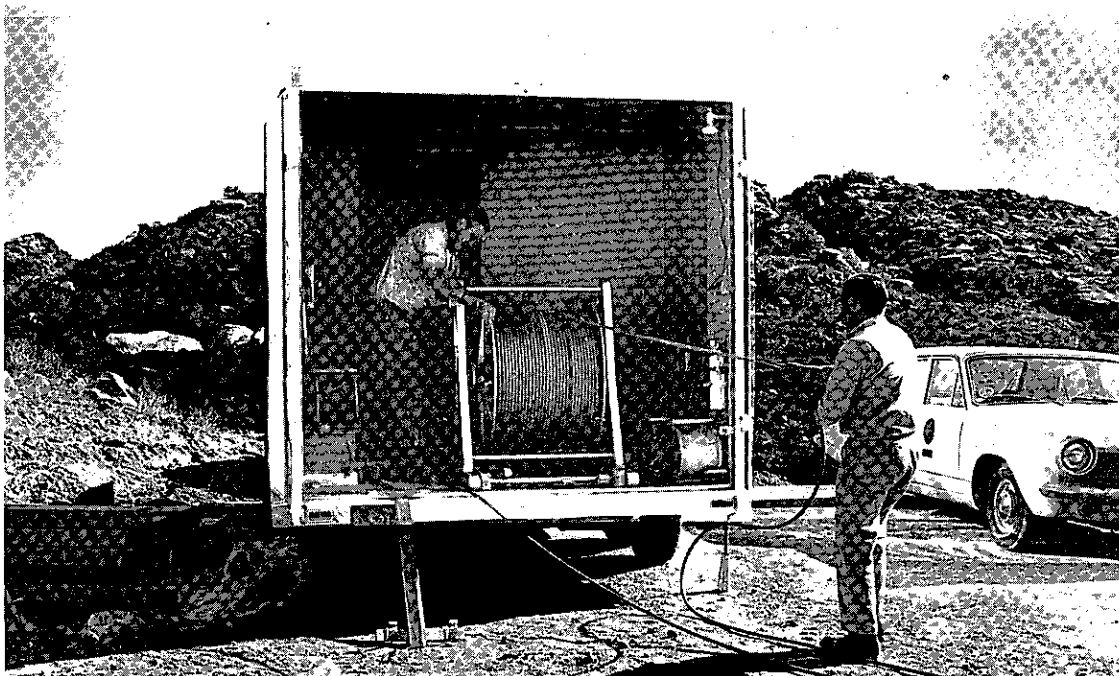
The bore hole probe is connected to the control desk by a 35 conductor cable which is water proof and has a tensile strength of approximately 1100 lbs. This cable is placed on a large winch located in the rear of the trailer for storage and ease of handling (see photo 4). Sufficient cable must be removed from the winch prior to entering the bore hole with the probe as a plug contact is used as a connector to the winch drum. The manufacturer states that a slip ring take-off from the drum is not practical.

Photo 4- Removing cable from winch mounted in rear of trailer.  
Note core boxes at Boring R-5, Santa Susana Pass.

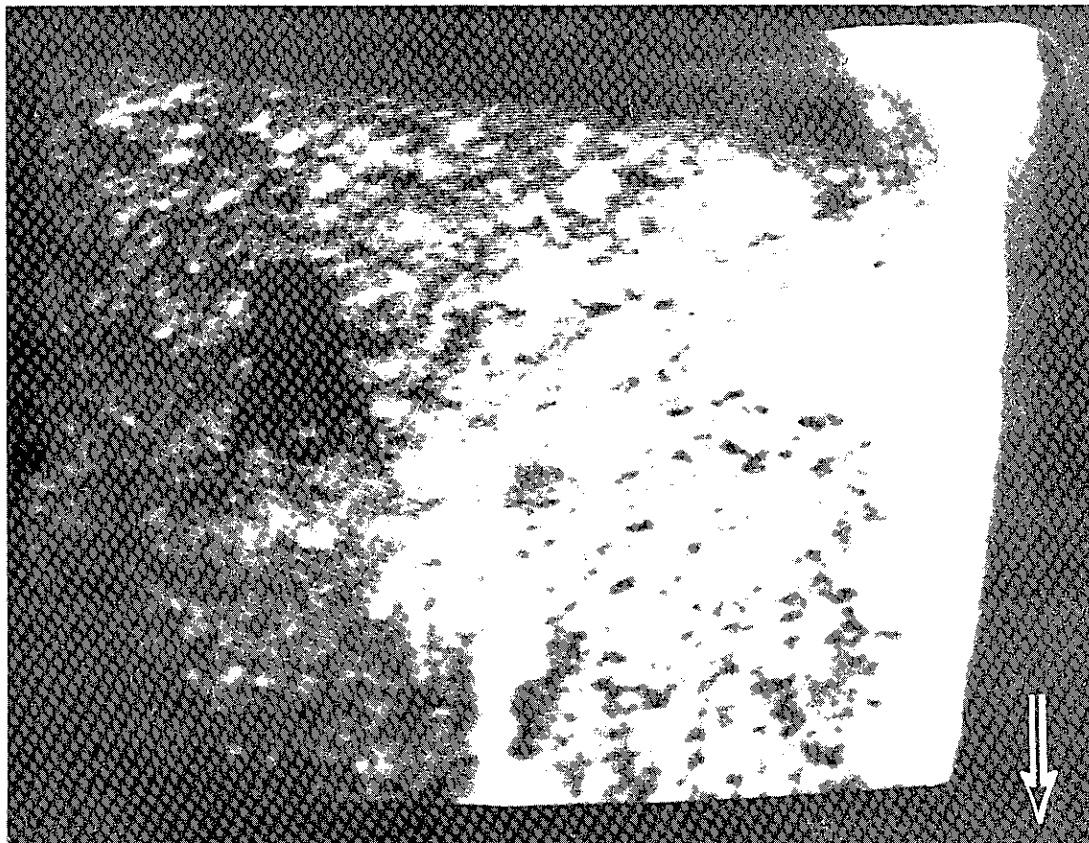
Photo 12 - Boring R-8 Santa Susana Pass 52.4 ft. Beetle on wall of boring. Beetle is about .6 inch long.
